WT-101

(6) DAMAGE TO EXISTING EPG STRUCTURES (U)

This report presents the final results of one of the projects participating in the military-effects programs of Operation Hardtack. Overall information about this and the other military-effects projects can be obtained from ITR-1660, the "Summary Report of the Commander, Task Unit 3." This technical summary includes: (1) tables listing each detonation with its yield, type, environment, meteorological conditions, etc.; (2) maps showing shot locations; (3) discussion of results by programs; (4) summaries of objectives, procedures, results, etc., for all projects; and (5) a listing of project reports for the military-effects programs.

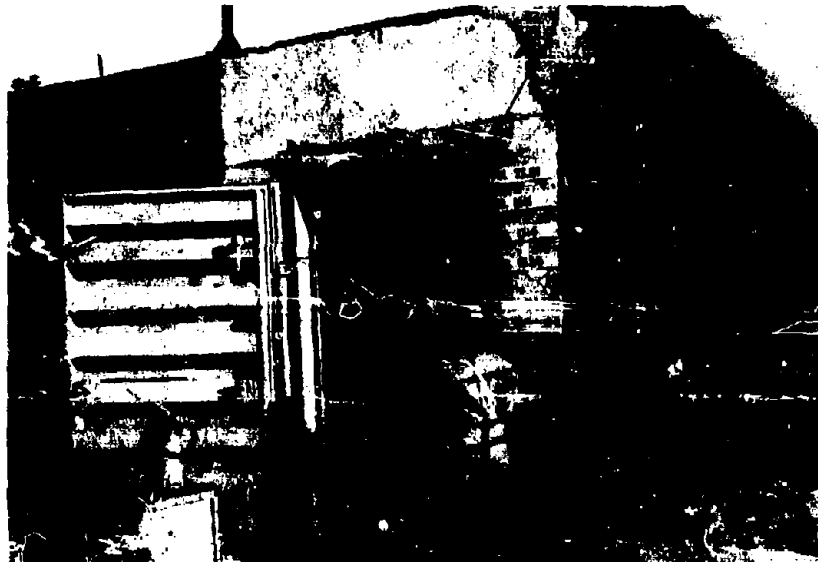
Figure 4.4 Preshot, (Item 18) station complex, close-up of entrance and crack in wing wall, Site Irene.

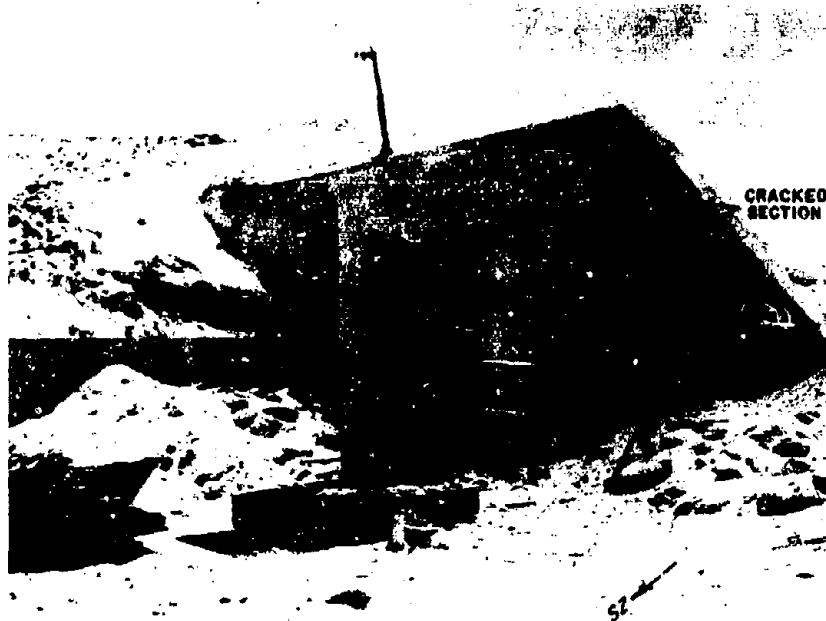
Figure 4.5 Post-Yellowwood, (Item 18) station complex, close-up of entrance and cracked wing wall. Pressure levels: Koa, 42 psi; Yellowwood, 11.5 psi; and Tobacco, 1.9 psi.

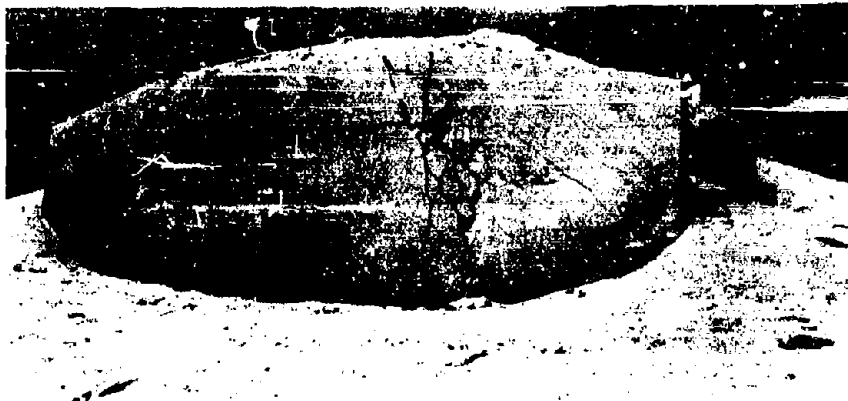
Figure 4.9 Post-Koa, (Item 19) Station 1525, face-on view.
Pressure level: Koa, 42 psi; 350 cal/cm^2 .

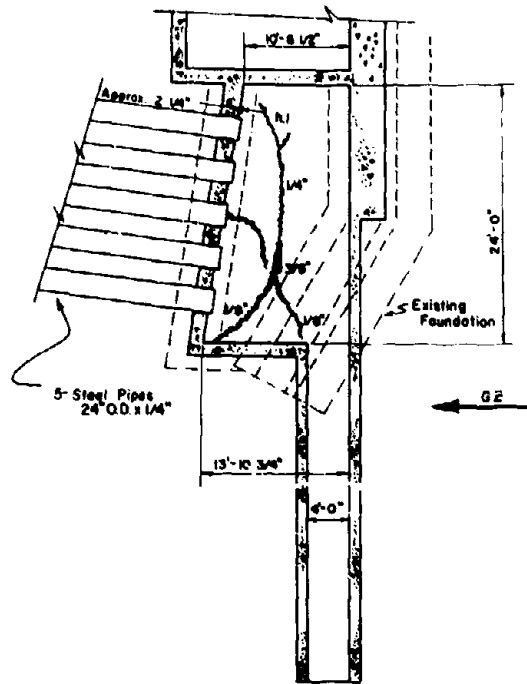
The plain-concrete floor of this station was badly cracked and the five 24-inch pipes entering this station were forced inward about $2\frac{1}{4}$ inches (Figure 4.18). The crack pattern (shown in Figure 4.19) indicates that the existing foundation underneath part of the floor gave additional support to that portion.

Figure 4.19 Post-Koa, (Item 20) Station 1311, crack pattern in floor. Pressure level: Koa, 42 psi.

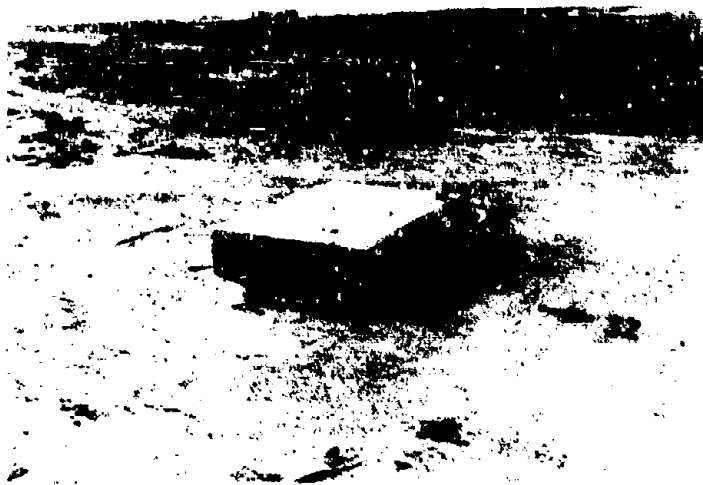
Figure 4.33 Post-Walnut, (Item 25) Station 1312, erosion adjacent to foundation. Pressure level: Walnut, 33 psi; Elder, 58 psi; 450 cal/cm².

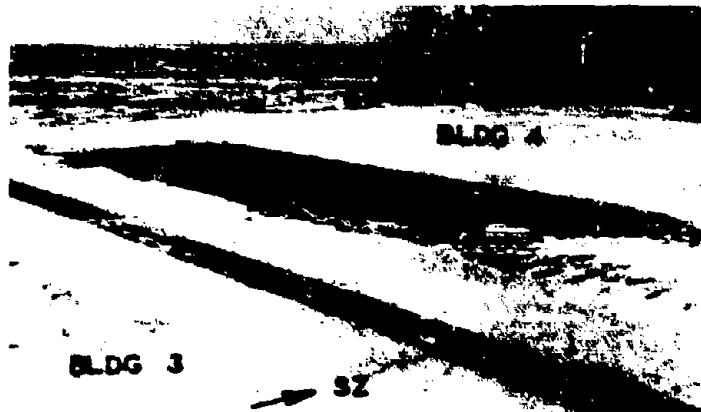
Figure 4.62 Post-Elder, (Item 26) Station 3.1.1, outside view of punched-in roof section at north end of Building 4. Pressure level: Elder, 20 psi.

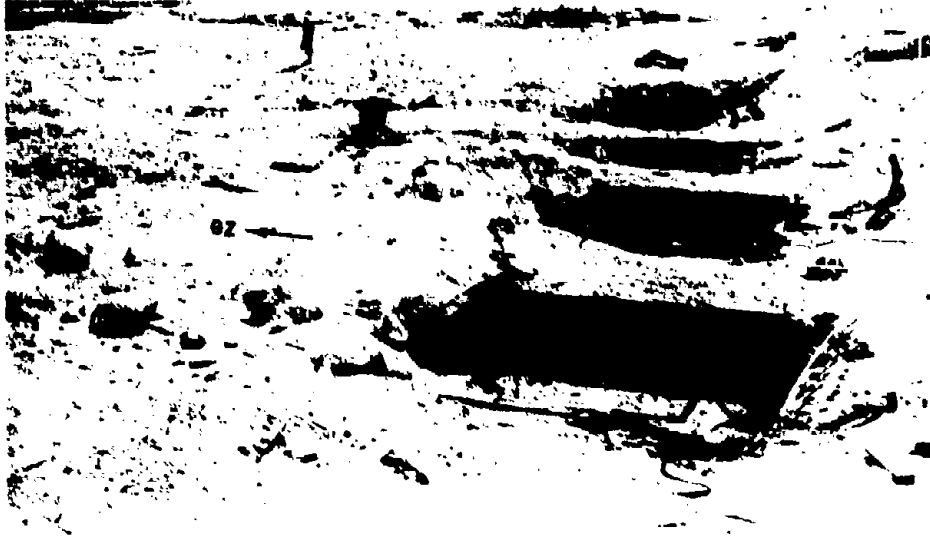
Figure 4.92 Post-Cactus, (Item 35) Stations 1523.01 to 1523.04, foundation pit for towers. Pressure level: Cactus, 450 psi.

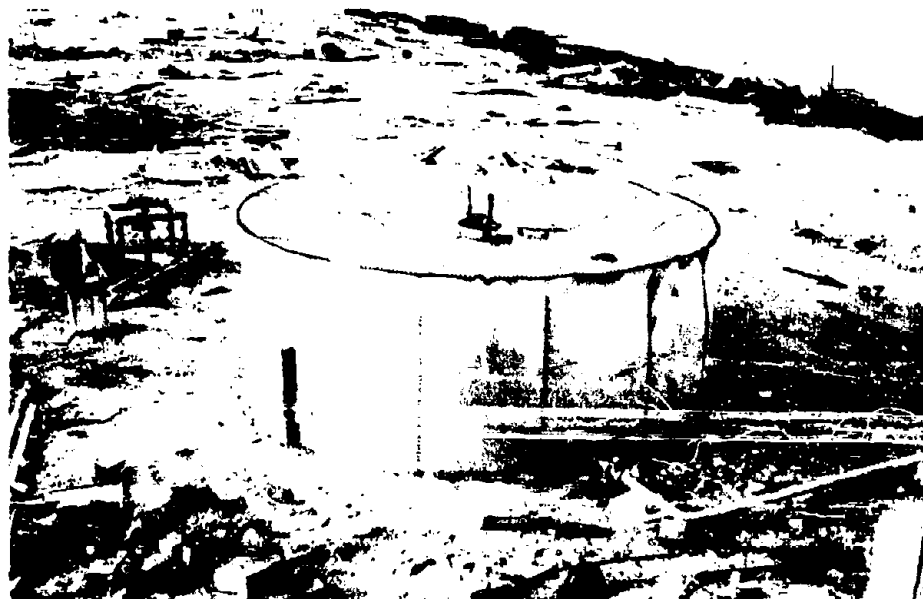
A ground-surface 21,000-gallon water tank of 1/4-inch bolted steel plate, 8 feet high and 22 feet in diameter, suffered only light damage when exposed to pressures of 6.5 and 7.0 psi.

Figure 4.97 Post-Magnolia, (Item 37) 21,000-gallon water tank and
Yvonne Camp area. Pressure level: Magnolia, 7.0 psi.

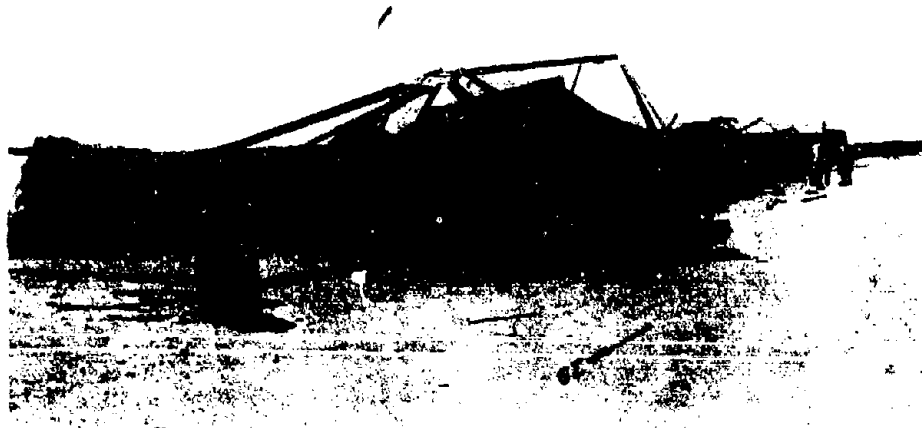
Figure 4.98 Post-Cactus, camp damage, tents. Pressure level: Cactus, 2.0 psi.

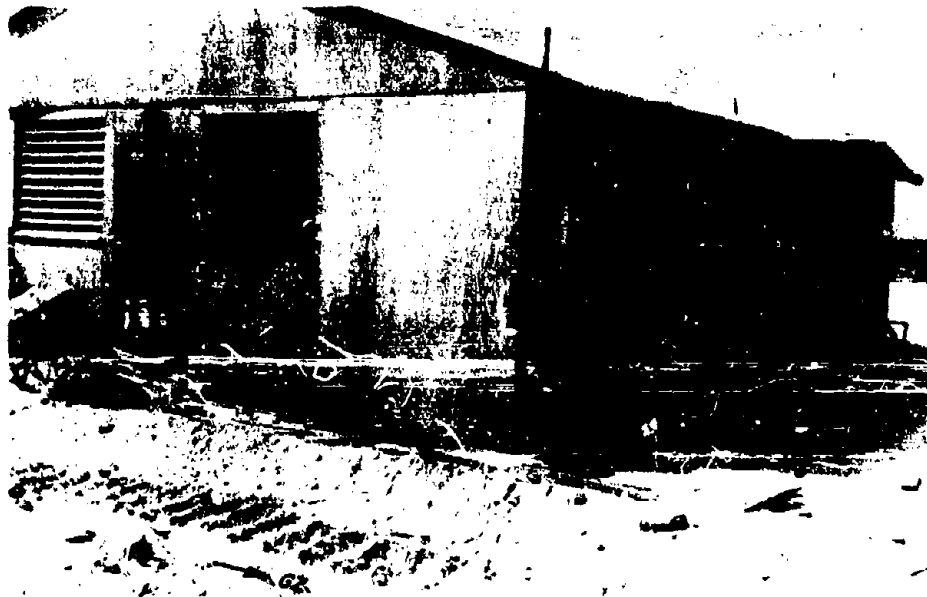
Figure 4.100 Post-Cactus, camp damage, latrine. Pressure
level: Cactus, 2.0 psi.

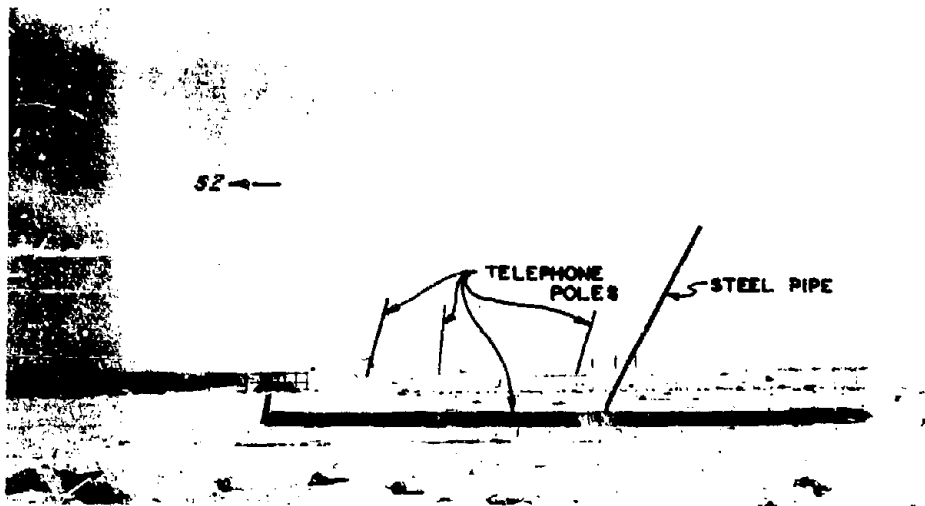
Figure 4.101 Post-Butternut, telephone poles. Pressure level: Butternut, 12 psi.
